Confidential Inspection Report

LOCATED AT:
Rockford, IL 61107

INSPECTED ON:
Monday, August 26, 2024

Inspector, John Ponio 450.013115
JWPServices, PLLC

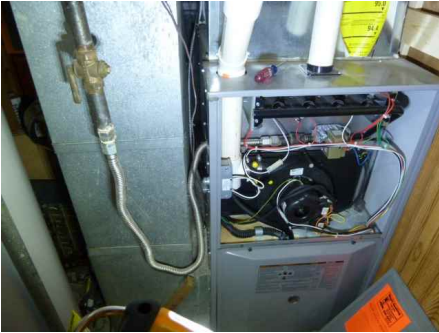
MGR The fuel piping does not include a 'T' extension to collect condensation and debris, as is considered good practice. In the course of future upgrading or repair, a 'drip leg' should be added to the gas piping just ahead of the connector.

Repair needed. No drip leg below shutoff valve. Flexible connection inside furnace cabinet.

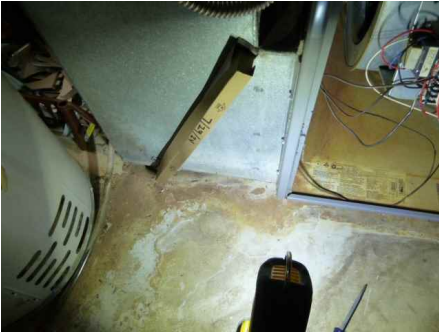
Water stains on floor and inside furnace cabinet. Past humidifier leak possible

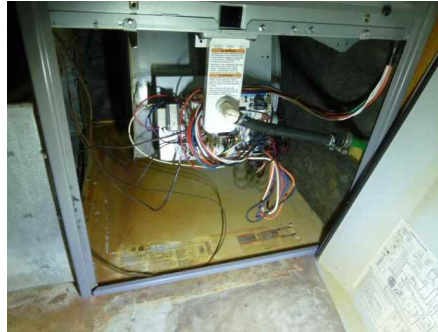
Water stains inside furnace cabinet.
Monitor humidifier filter

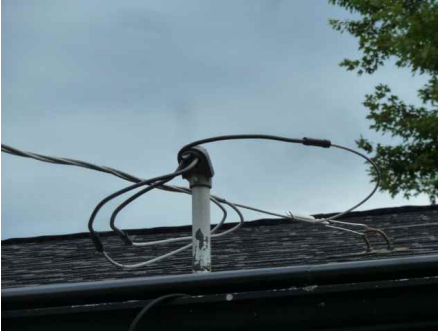
The overhead service conductors over the roof are too low by present standards. Ideally, the service drop should be replaced or reconfigured. Upgrading may not be practical, but we do urge caution when working near these wires.

Overhead service weather head too low for proper drip loop height

The service entrance conductors do not have a proper drip loop to prevent water from entering the mast. We recommend modification of the service drop, in accordance with present standards.

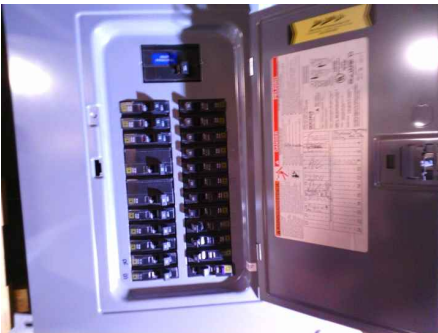
Incomplete panel labeling

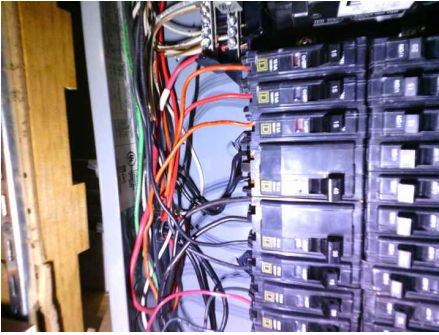
Two wires under single neutral screws.
Rust on 40-amp breaker screws.

For attention to the condition(s) noted above, and/or cost estimates, if necessary, we recommend the advice and services of a licensed electrical contractor.

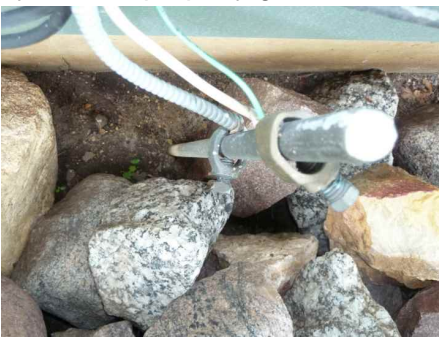
The electrical system is not properly grounded. This is a potential safety hazard. We recommend the system be properly grounded in accordance with present standards.

Two ground wires under one nut not correct

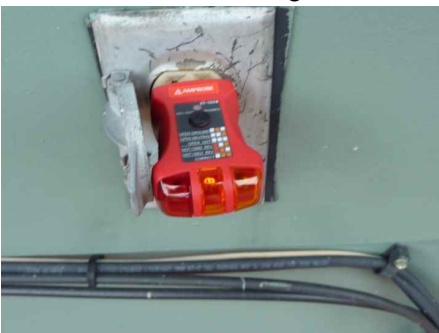
GFCI protection is installed for receptacles in the kitchens, bathrooms and at the front exterior receptacle. No GFCI's are installed in the garage, at the rear patio outlet or at the sump pump in the basement where this type of protection is presently required. The lack of GFCI receptacles presents an unsafe condition in these areas. We recommend receptacles in these areas be updated by a licensed professional.

Rear deck receptacle not grounded and no GFCI installed. Safety issue. Correction needed

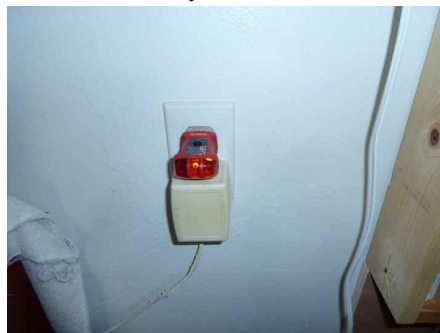
Garage receptacle not properly grounded and no GFCI. Correction needed

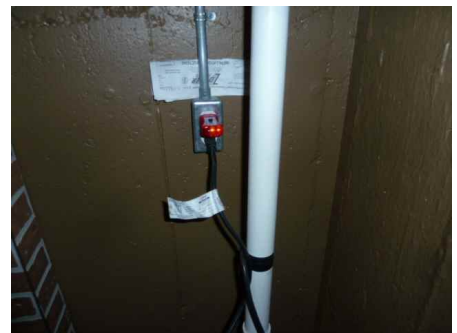
Sump pump receptacle properly grounded but should have GFCI protection

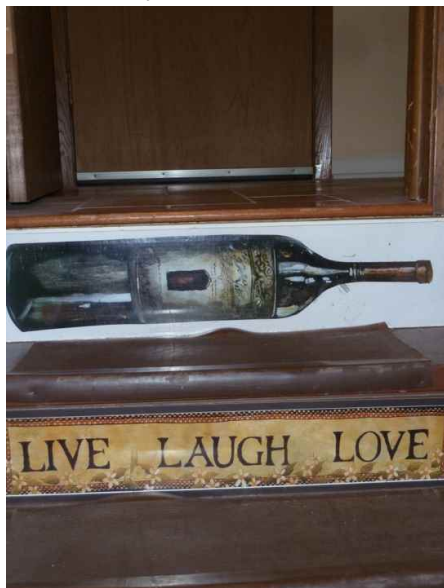
The risers of the stairs are not uniform and therefore pose a potential 'trip' hazard. Ideally, the stairs should be modified to ensure they comply with present building standards and safety regulations. The kitchen flooring was upgraded to ceramic tile and the addition of the tile and underlayment caused the finished floor elevation to be about 3/4" higher so that the first riser at the top of the stairs is higher than the remaining basement stair risers. This is not easily correctable. In addition, the treads of the basement stairs are narrower than current standards. Based on the location of the stairs this condition is not changeable without major structural modifications. This is an older home built by acceptable standards at the time of original construction. Extra care should be taken to ensure safe travel when using the stairs. The handrails are also installed differently today. A licensed carpenter can provide recommendations for other safety ideas.

Top riser higher due to floor upgrade in kitchen. Possible trip hazard

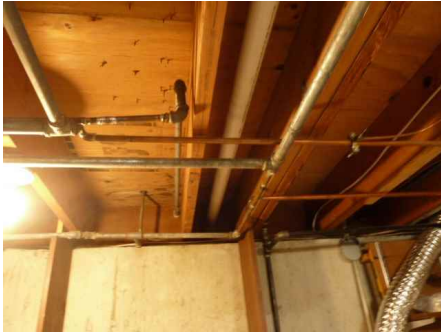
Portions of the domestic water supply piping have been installed in a substandard manner. The existing piping has been in place for some time and upgrading would be considered optional. There are dissimilar types of metal supply piping including galvanized steel and copper pipes and fittings. All connections should have dielectric unions at each location of dissimilar metal connection to inhibit corrosion.

Copper and galvanized water supply connections incorrect. Corrosion probable

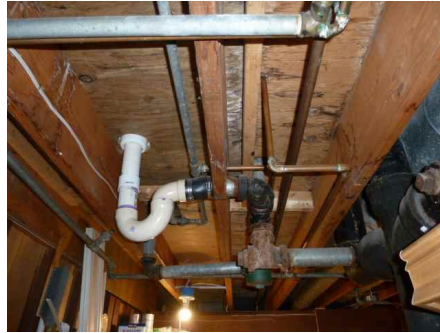
Water supply connections incorrect. Recommend repair or replacement

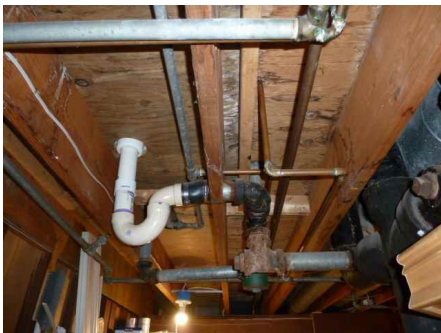
Staining was present in the basement below the kitchen and bathrooms, suggesting prior leakage. This area should be monitored for signs of active leakage.

Staining under bathroom area. Monitor for leaks

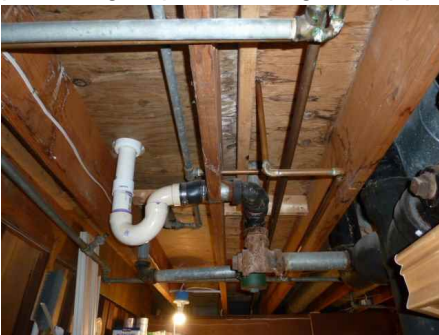
Notched joist where drain passes through it. Monitor and repair if needed

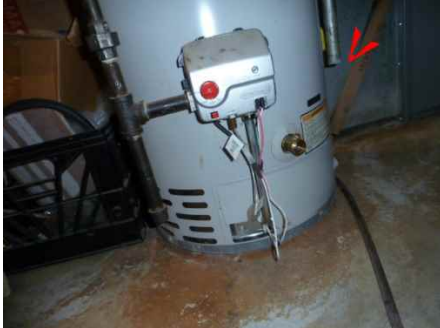
Overflow tube from pressure relief valve too short. Safety issue

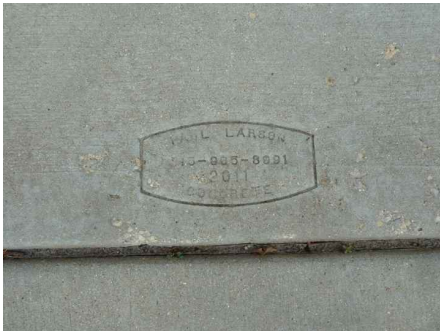
Concrete drive and sidewalk installed in 2011. Minor spalling due to salt use

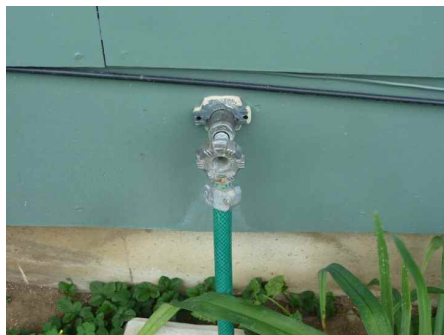
MNR The rear hose bib(s) is dripping when the valve is turned on. The stem is stripped so the handle cannot be secured to the stem. I recommend replacement of the hose bib since it is worn and leaks when in use. Upgrading to a frost proof hose bibb with back flow prevention will meet current standards. I recommend at a minimum the washer be replaced and/or the packing nut be tightened.

Rear spigot leaks when opened. Needs repair

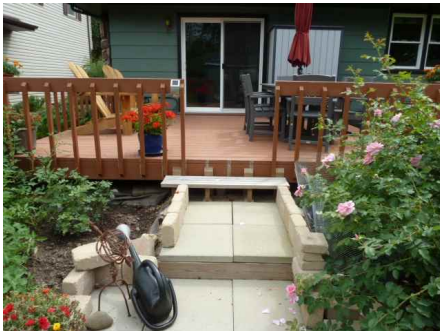
The railings at the rear deck are installed in a substandard manner. We recommend they be repaired or replaced.

Rework railing as necessary for safety reasons

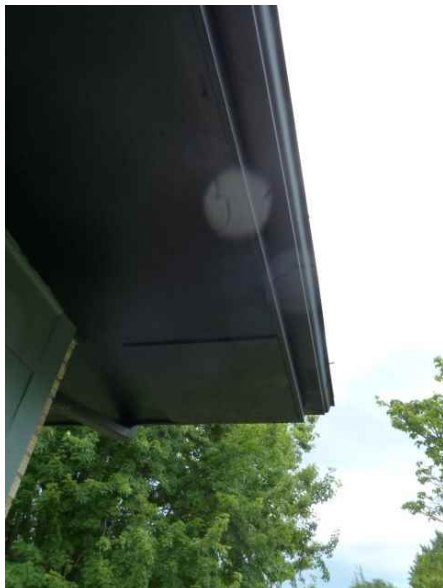
The eaves and overhangs appear to be properly installed and generally in good condition, with exceptions noted below. There is a plywood patch at the southeast corner of the structure. There was probably some moisture damage at some point in the past. Monitor this area for signs of leaks.

Small plywood patch at corner of soffit

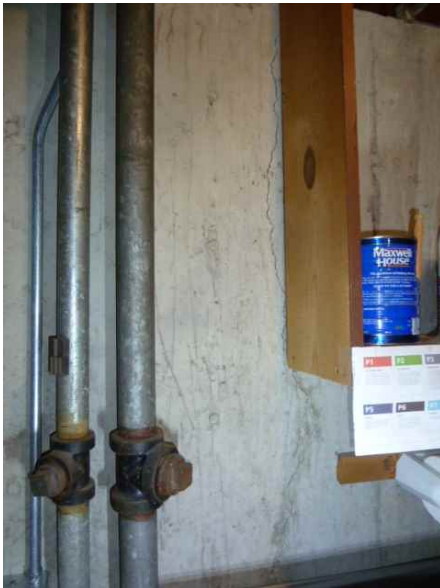
There are small cracks visible. We observed no related conditions suggesting the need for immediate repairs. We recommend these cracks be monitored. If ongoing movement is observed, further review would then be recommended. Sections of the perimeter basement walls are finished with drywall or paneling so the concrete foundation wall is not visible in those areas and therefore could not be inspected.

Small crack in foundation at west wall.
Monitor for changes or moisture penetration

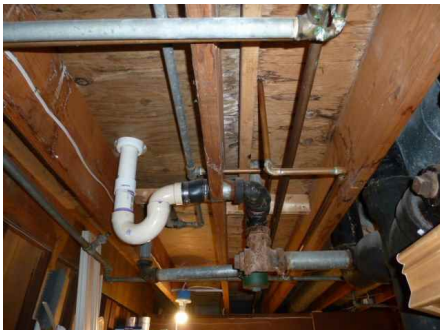
There were water stains in several areas. The areas were dry at the time of this inspection. These areas are visible from the unfinished areas of the basement under the bathrooms and kitchen area. These areas should be monitored for potential future leaks and repaired if necessary. The wood subfloor appeared to be in generally sound condition at the time of my inspection.

Stains on subfloor. Monitor for leaks

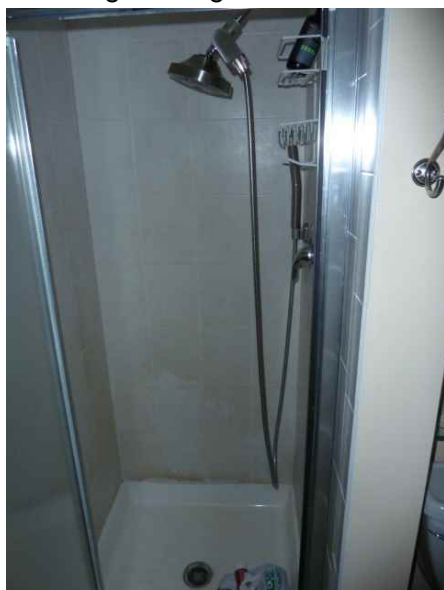
The shower walls appear to be properly installed and in serviceable condition. However the shower walls show signs of age. We recommend resealing joint between walls and shower pan.

Reseal wall to shower base connection

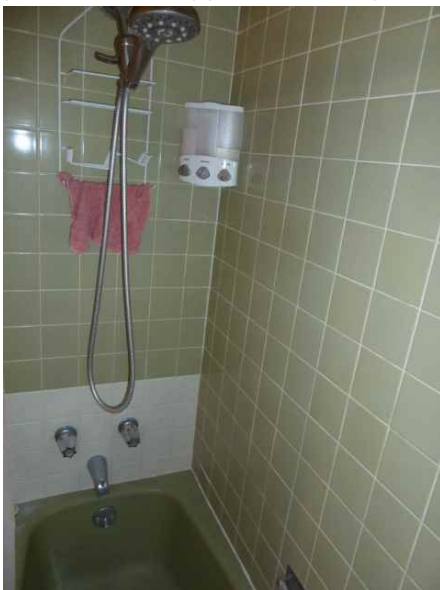
The drain stop is missing. A removable stainless-steel strainer is inserted into the drain to collect hair or other items that may enter the drain. A rubber plug is used in place of a permanent drain stopper as the permanent stopper needs repair.

Missing drain stopper. Previous faucet replacement assumed by ceramic tile patch

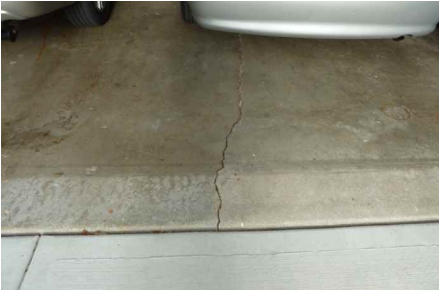
There are large cracks in the floor slab. These are basically cosmetic considerations and action is considered optional. However, this condition does indicate movement in the soil and additional floor movement can be expected in the future. This cracking is most likely caused by initial settlement due to excavation at the time after construction. The ground may have stabilized but the possibility of other cracks or shifting of the slab is possible.

Cracks in garage floor due to settling.
Monitor for changes

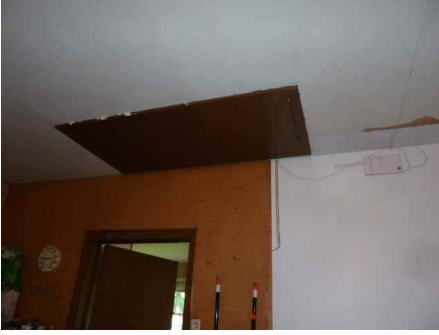
The access to the attic is open. This condition could lead to a more rapid spread of the smoke and flames in a fire. We recommend covering the access into the attic in accordance with present standards.

Attic access in garage is a fire safety concern.

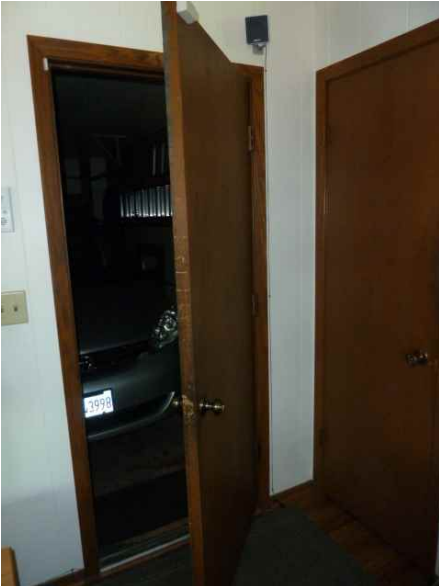
The door between the garage and the living space is of fire resistive construction. However, the door is not self-closing. We recommend the door be upgraded by installing a spring hinge or an automatic closer.

No self-closer on entry door to interior of home

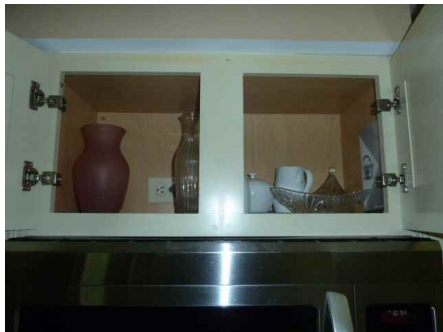
Kitchen ventilation is provided by a microwave over the burners. The fan does not vent to the exterior but exhausts into the kitchen space. It is recommended that kitchen fans vent to the exterior.

No kitchen ventilation to the outside
