Confidential Inspection Report

LOCATED AT:
Rockford, IL 61107

INSPECTED ON:
Monday, August 26, 2024

Inspector, John Ponio 450.013115
JWPServices, PLLC

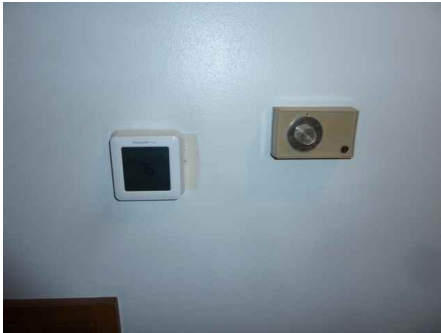
Programmable Thermostat and
Humidistat in Main Hallway

The thermostat appears to be properly installed and the unit responded to the basic controls. This is a programmable device with many options for setback settings, timed events, etc. No attempt was made to test all functions of the thermostat.

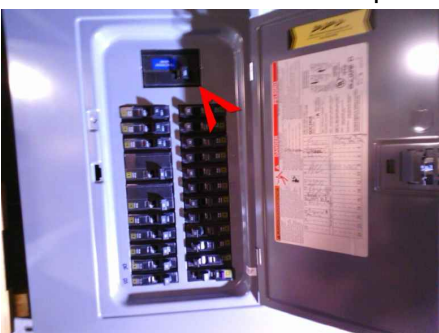
Main Electrical Disconnect at west wall in
basement laundry area

The main disconnect is incorporated into the electrical service panel.

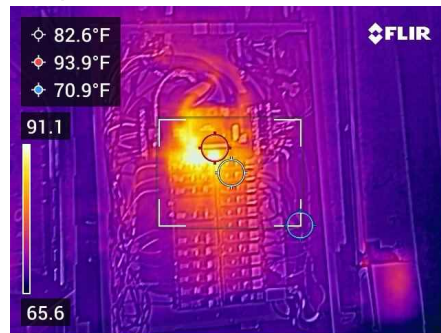
Thermal Image. No hot spots in main electrical panel. Furnace drawing load

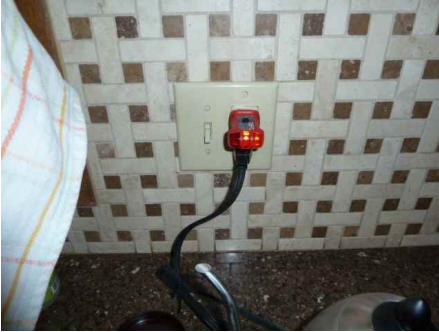
Properly wired GFCI outlet at kitchen sink area

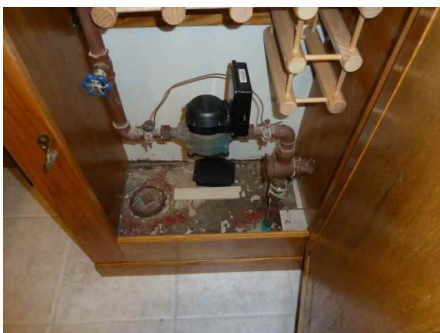
The domestic water supply main shut-off valve is on the front wall in the basement across from the bottom of the stairs.

Water shut off and sewer cleanout in basement across from stairs in cabinet

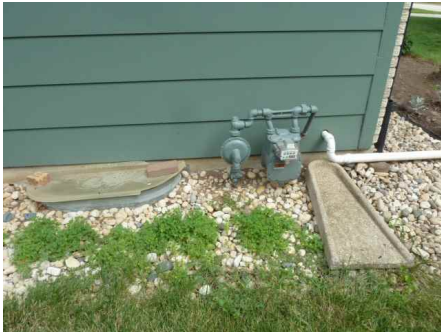
The gas meter is outside on the left(south) side of the building. The main gas supply shutoff valve is located on the riser pipe between the ground and the meter. This valve should be turned 90 degrees (either way) in order to shut off the gas.

Gas meter located at southeast corner of structure

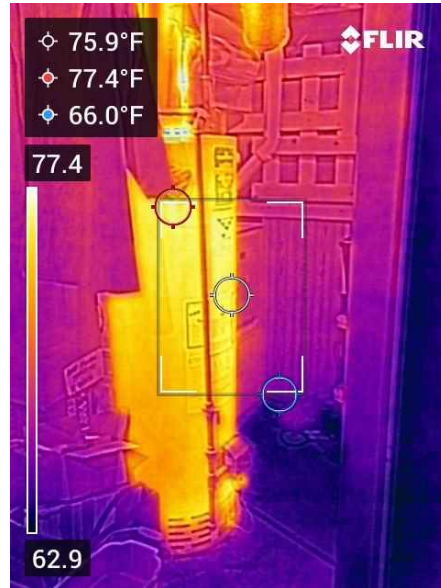
Thermal image of water heater operating

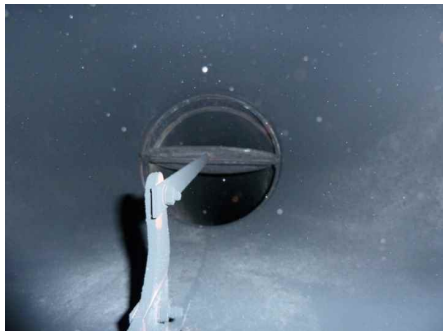
The fireplace appears to be properly installed and in serviceable condition with no signs of excessive or unusual wear. The glass fireplace doors bind a little when opening and closing. The damper opened and closed and appeared to be functioning properly.

Manually operated damper open and closed

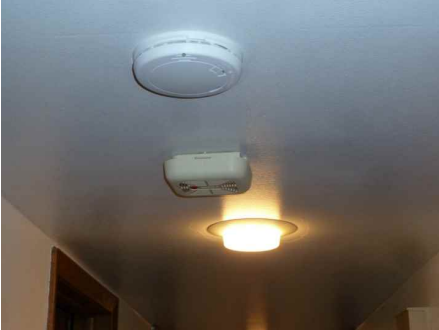
Smoke Alarms in main hall near bedrooms

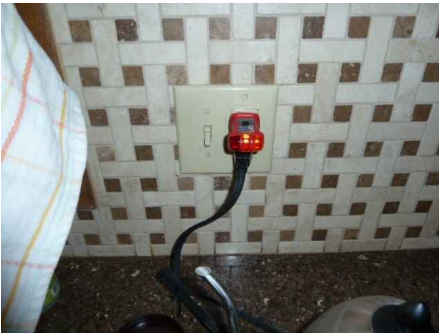
GFCI (ground fault circuit interrupter) protection has been installed providing an increased margin of safety. We recommend testing the device on a monthly basis.

GFCI protected receptacle near kitchen sink area

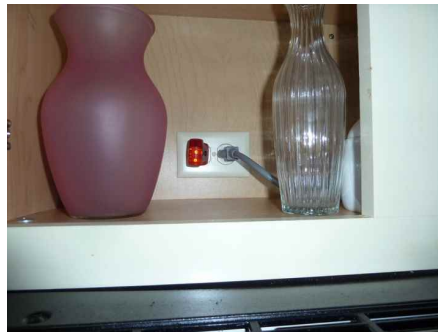
Microwave outlet properly grounded

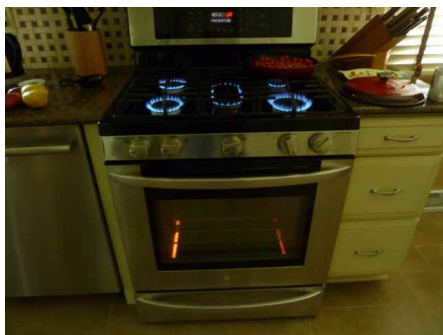
The stove was turned on with the normal operating controls and found to be in satisfactory working condition.

Oven and stovetop burners in operation

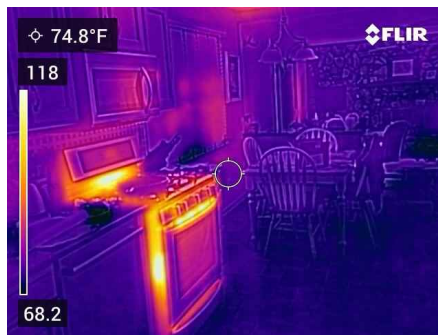
Thermal Image of oven operating

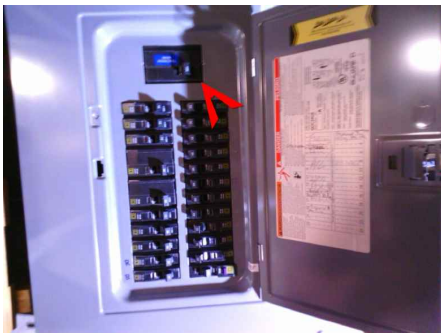
Main Electrical Disconnect at west wall in basement laundry area

The main disconnect is incorporated into the electrical service panel.

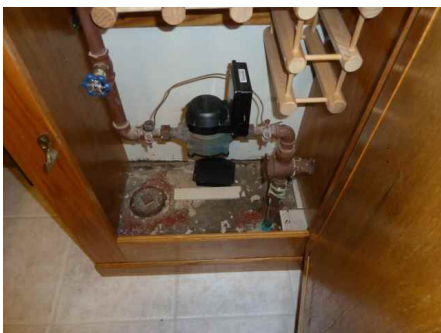
The domestic water supply main shut-off valve is on the front wall in the basement across from the bottom of the stairs.

Water shut off and sewer cleanout in basement across from stairs in cabinet

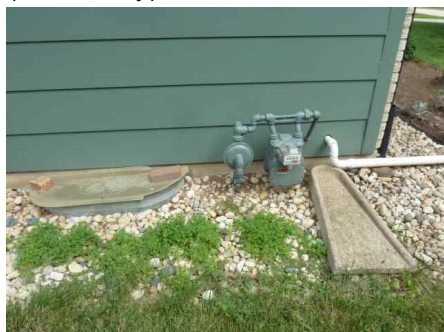
The gas meter is outside on the left(south) side of the building. The main gas supply shutoff valve is located on the riser pipe between the ground and the meter. This valve should be turned 90 degrees (either way) in order to shut off the gas.

Gas meter located at southeast corner of structure
